Manhole Inspection Summary

Manhole # **S17C__008MH**

Insp Date: **10/8/07 11:35 AM**

Location Address: **2438 FRANKLIN ST**

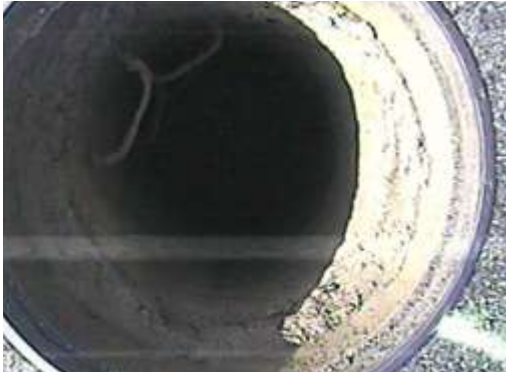
Defect 1

Offset: **3** (in.)

FRAME OFFSET

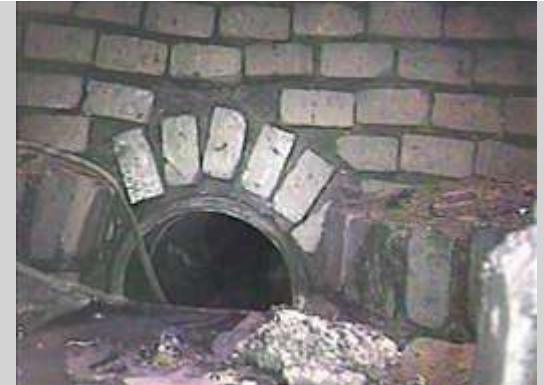
12 O'Clock Outflow

8 in. Circular Gravity Sewer
Pipe Out @ 12 O'Clock

Pipe Height: 6 (in.) Rod and Bar
Pipe Material: **Clay** ☐ Pipe Lined
Invert Depth: 12.90 (ft.) Flow Characteristics: **Slow**
Deposits: ☐ None ☐ Mud ☐ Gravy ☒ **Debris** ☐ Grease
Silt Depth: 2 (in.) Deposits Extent: **Medium**
Infiltration: **None** Pipe Seal Cond: **Sound**

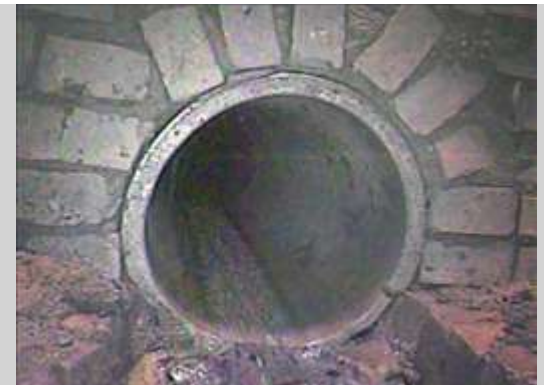
3 O'Clock Inflow

8 in. Circular Gravity Sewer
Pipe In @ 3 O'Clock

Pipe Height: 8.4 (in.) Rod and Bar
Pipe Material: **Clay** ☐ Pipe Lined
Invert Depth: 12.26 (ft.) Flow Characteristics: **Slow**
Deposits: ☒ None ☐ Mud ☐ Gravy ☐ **Debris** ☐ Grease
Silt Depth: (in.) Deposits Extent:
Infiltration: **None** Pipe Seal Cond: **Sound**

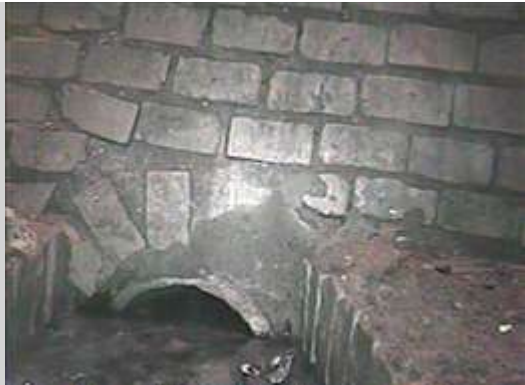
6 O'Clock Inflow

Pipe In @ 6 O'Clock

Deposits: ☐ None ☐ Mud ☒ Sludge ☒ Debris ☐ Grease

Silt Depth: **3** (in.) Deposits Extent: **Medium**

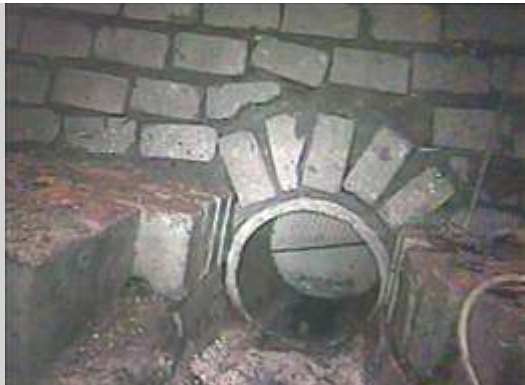
9 O'Clock Inflow

Pipe In @ 9 O'Clock

Connects To: **Stub connection / abandoned**
